Manhole Inspection Summary

Manhole # S23M__009MH

Insp Date: **6/24/08 1:41 PM**

Location Address: **425 S Vincent St (behind address)**

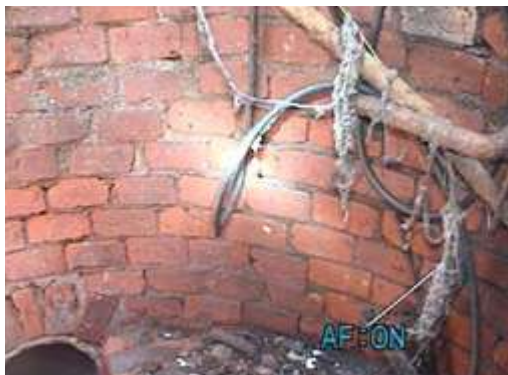
Defect 2

Condition: ☐ Sound ☐ Cracked ☐ Root Intrusion ☐ Deteriorated ☐ Leaks ☒ **Debris**

Count: **3** Missing: **0** ☒ **Corroded**

steps corroded, bench debris

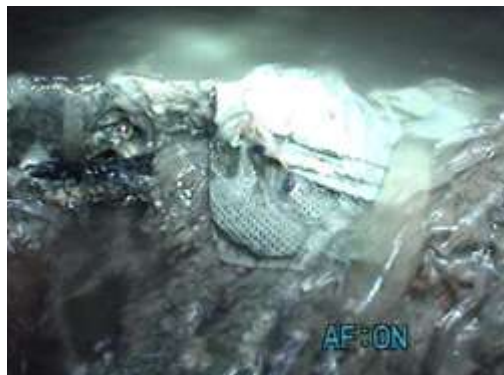
Defect 1

Condition: ☐ Sound ☐ Cracked ☐ Root Intrusion ☐ Deteriorated ☐ Leaks ☒ **Debris**

debris in channel

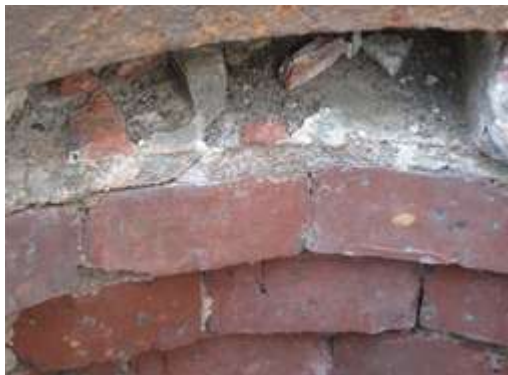
Defect 4

Condition: ☐ Sound ☒ **Cracked** ☐ Root Intrusion ☒ **Loose Brick** ☒ **Deteriorated**

chimney cracked

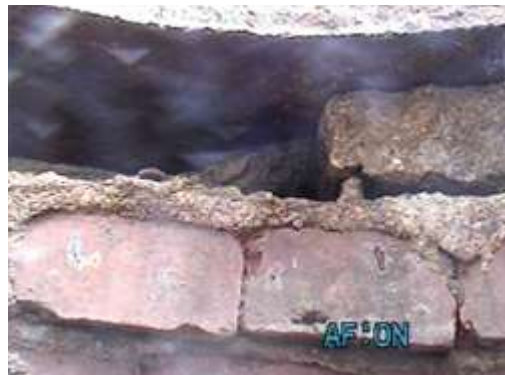
Defect 3

chimney loose bricks and deteriorated

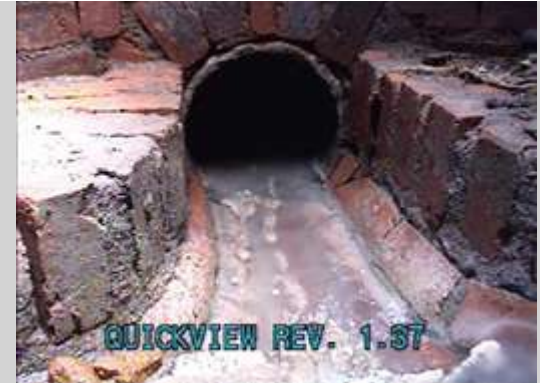
12 O'Clock Outflow

Pipe Height: **8.4** (in.) Rod and Bar (Angled)
Pipe Material: **Clay** ☐ Pipe Lined
Invert Depth: **6.45** (ft.) Flow Characteristics: **Fast**
Deposits: ☒ None ☐ Mud ☐ Sludge ☐ Debris ☐ Grease
Silt Depth: **0** (in.) Deposits Extent:
Infiltration: **None** Pipe Seal Cond: **Sound**

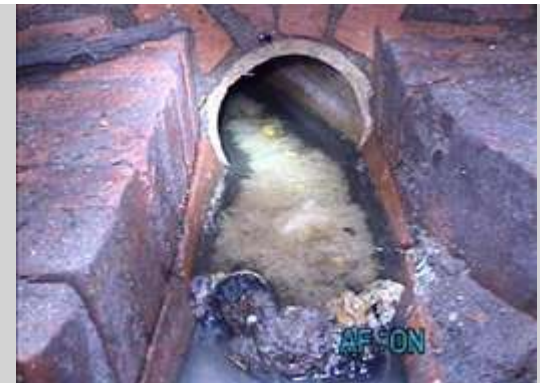
3 O'Clock Inflow

Pipe Height: **6** (in.) Rod and Bar (Angled)
Pipe Material: **Clay** ☐ Pipe Lined
Invert Depth: **6.17** (ft.) Flow Characteristics: **Slow**
Deposits: ☒ None ☐ Mud ☐ Sludge ☐ Debris ☐ Grease
Silt Depth: **0** (in.) Deposits Extent:
Infiltration: **None** Pipe Seal Cond: **Sound**

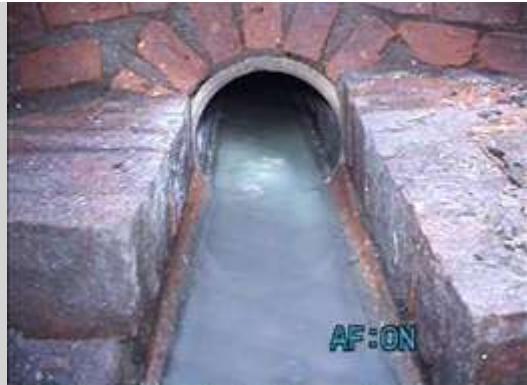
6 O'Clock Inflow

Pipe Height: **8.4** (in.) Rod and Bar (Angled)

Infiltration: **None** Pipe Seal Cond: **Sound**

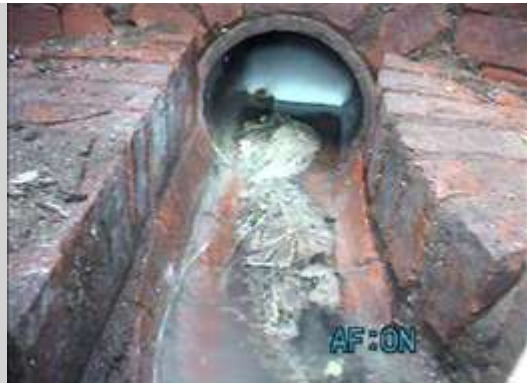
9 O'Clock Inflow

Pipe Height: **8.4** (in.) Rod and Bar (Angled)

Infiltration: **None** Pipe Seal Cond: **Sound**
